Site Name: <u>Progress Energy Asheville</u>	Date: <u>29 MAY 2009</u>
Unit Name: <u>1964 POND</u>	Operator's Name: <u>PROGRESS ENERGY</u>
Unit I.D.:	Hazard Potential Classification: <u>High</u> Significant Low
Inspector's Name: <u>FREDERIC SHMURAK / JUSTIN STORY</u>

Site Name: Progress Energy Asteville Date: 29 May 2009
 Unit Name: 1982 Pond Operator's Name: PROGRESS ENERGY
 Unit I.D.: _____ Hazard Potential Classification: High Significant Low
 Inspector's Name: Frederic Shmurak / JUSTIN STORY

PHOTOGRAPH LOCATION PLAN
ASH PONDS - PROGRESS ENERGY
ASHEVILLE STEAM ELECTRIC PLANT
SKYLAND, NORTH CAROLINA

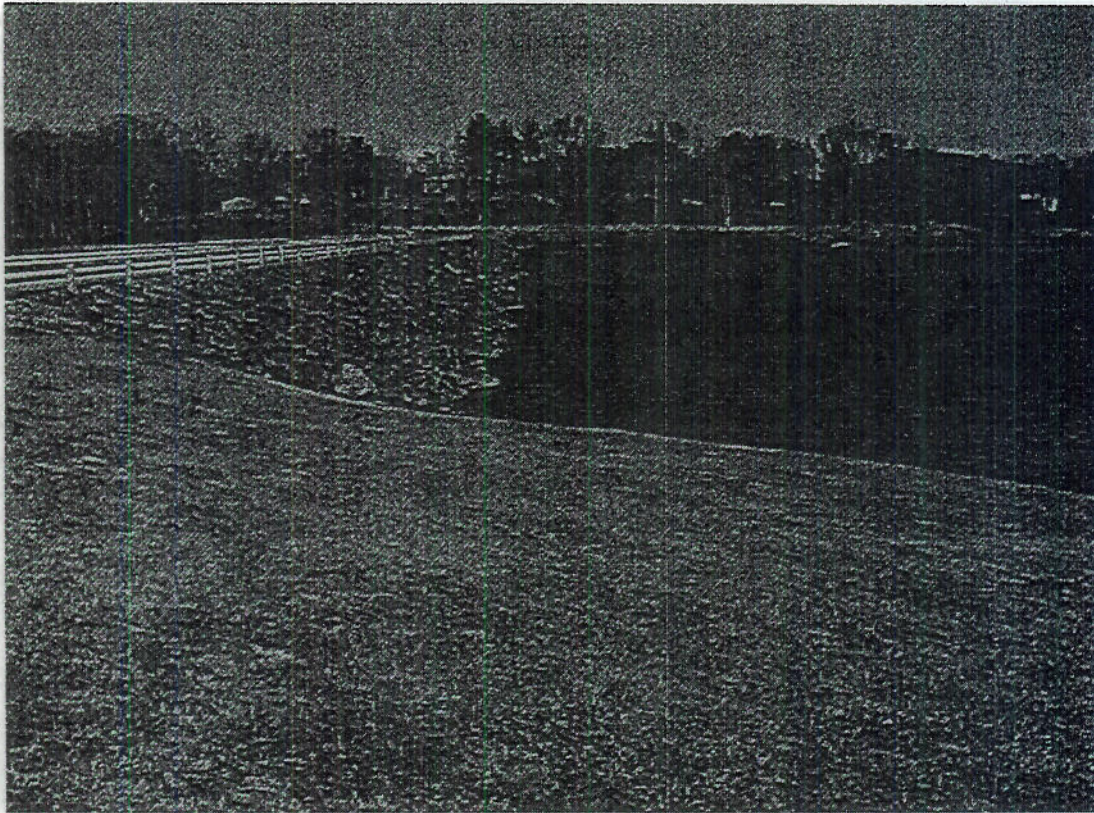
The upstream slope of the dam is well rip-rapped with sound, angular rocks (local mica gneiss) up to 2 feet in size. The slope is approximately 2(H):1(V), with some minor undulations. The rip-rap is free of vegetation and in good condition (photograph 1).

Photograph 1: Cooling Lake Dam – upstream slope looking north.

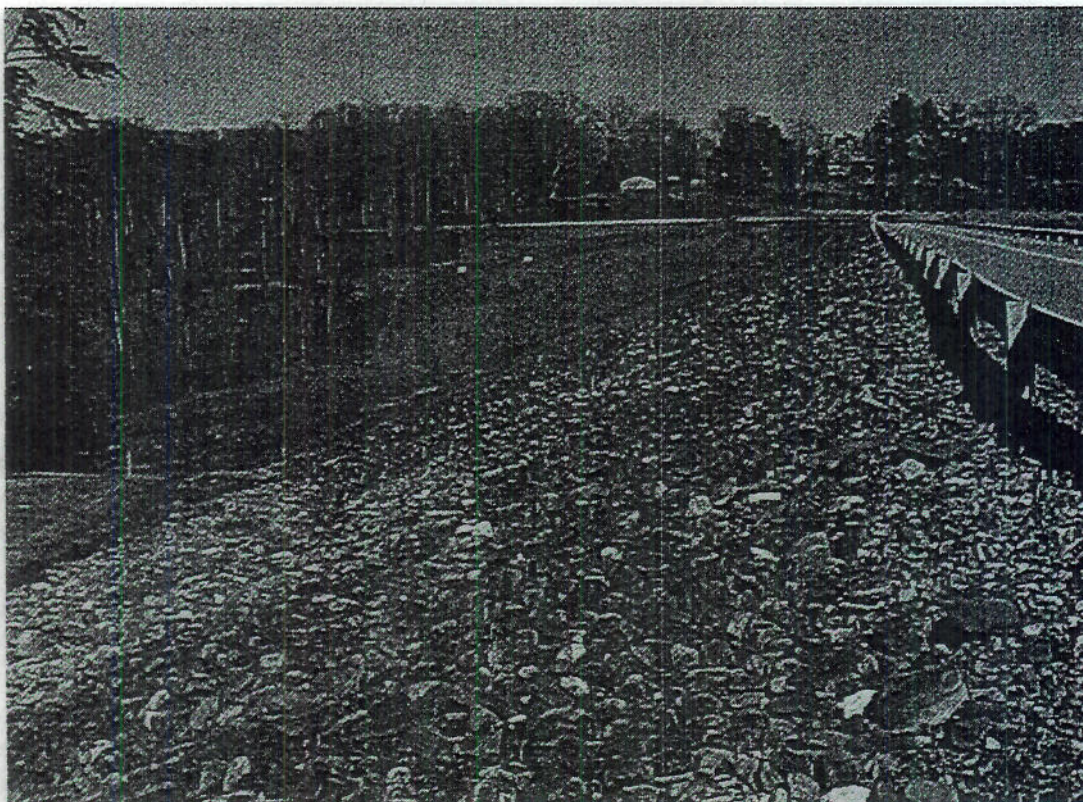
No cracks were noted in the asphalt pavement along the crest of the dam. The downstream slope is in good condition with no vegetation and no evidence of slumping or surface movement (photographs 2, 3). No seepage from beneath the rip-rap at the toe of the dam along the contact with the south abutment was noted, as has been seen before. Woody vegetation had been cut back in the wet area downstream of the Cooling Lake Dam prior to our inspection (photograph 4). Localized seeps were noted within the cleared downstream area, south of the main seepage collection ditch, as in previous inspections. The seepage from this area and the main seepage collection ditch is measured at the weir (photograph 5) and was noted to be clear. Erosion/leaking around the north side of the measurement weir, noted in past inspections, has been repaired. No excessive accumulation of sediment behind the weir was noted.

Photograph 2: Cooling Lake Dam – downstream slope looking north.

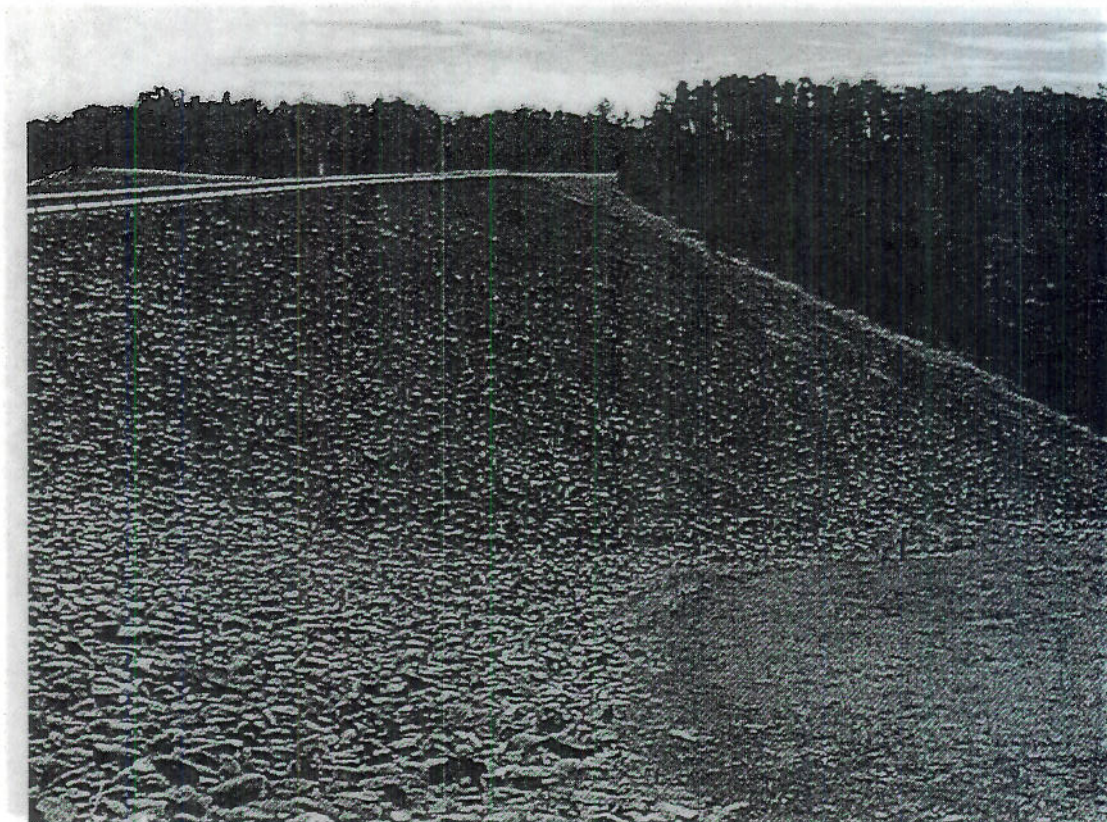
Photograph 3: Cooling Lake Dam – downstream slope looking south.

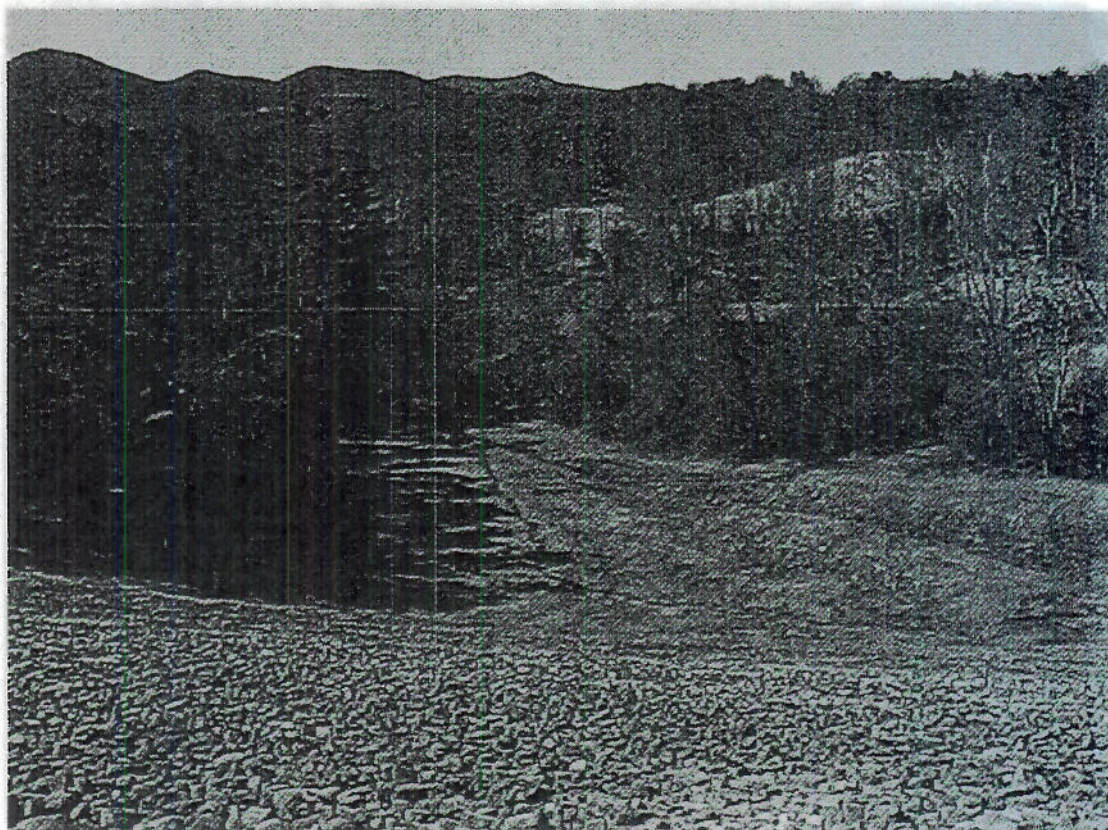
Photograph 4: Cooling Lake Dam – looking west, downstream of dam.

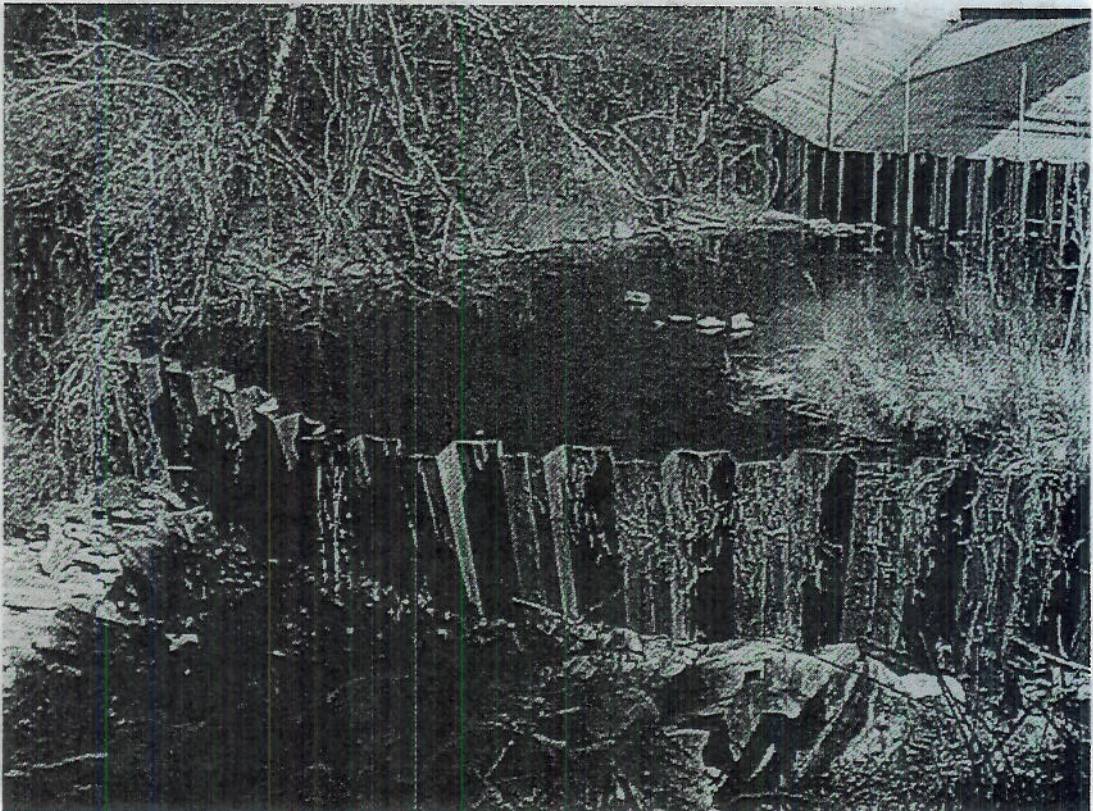
The stilling pools are also in good condition. The first stilling pool has scattered rip-rap along the bottom and is in about the same condition as reported in the 2002 inspection report. The displaced sheet piles creating this pool appear not to have changed, judging from previous reports (photographs 11 and 12). The second pool located downstream from the first also appears to be in generally good condition.

Photograph 12: Cooling Lake Dam – spillway drop walls and energy dissipation pool.

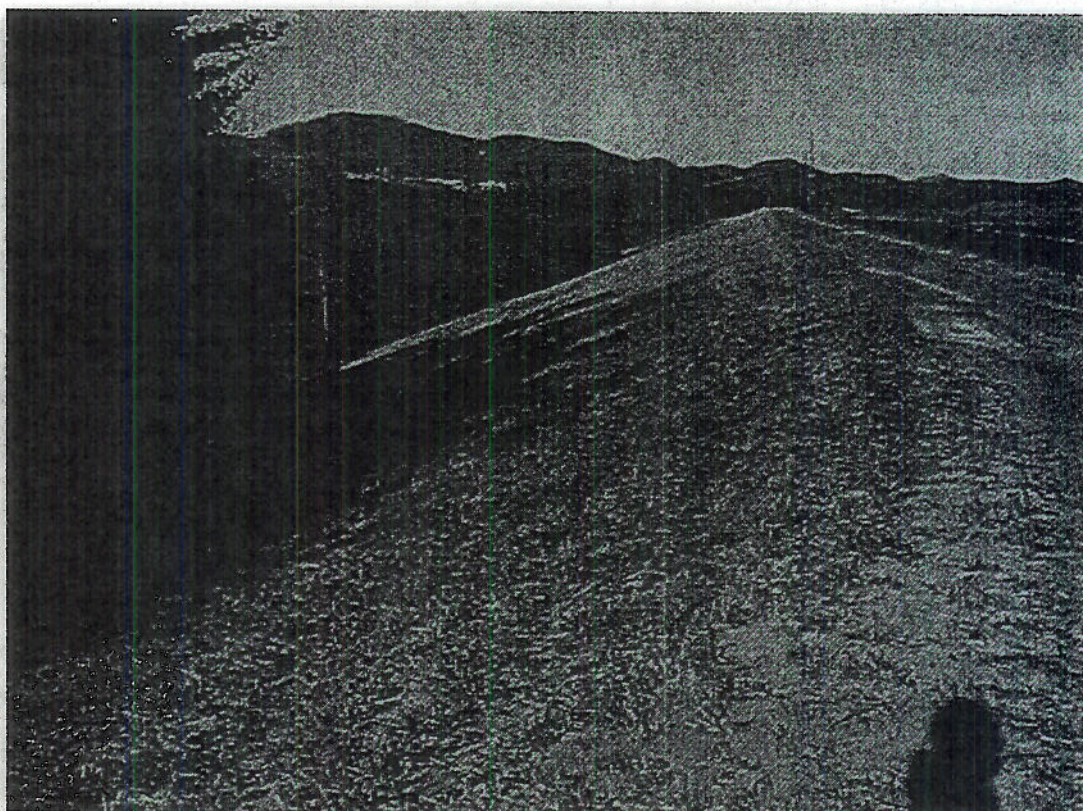
Photograph 17: 1982 Ash Pond – Crest and upper part of downstream slope, looking west.

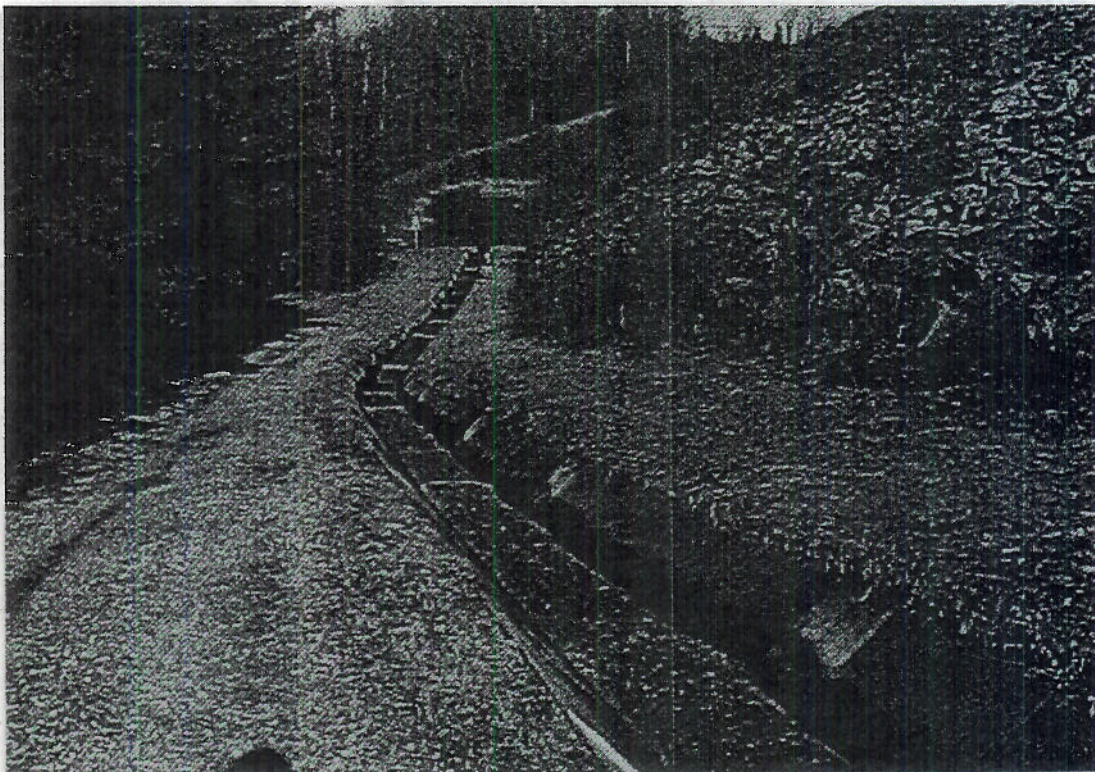
The caulked expansion joints in the concrete flume carrying discharge from the 1982 pond to the NPDES monitoring point at the toe of the 1964 pond dam were observed to be in good condition (photograph 22). No significant erosion or scaling of concrete was noted. Voids adjacent to the flume noted during the 1997 inspection at several locations along approximately the downstream half of the flume were filled with concrete shortly after the 2002 inspection (photograph 23). Discharge from the drainpipe installed below the downstream end of the concrete flume was observed to be clear (photograph 24).

Photograph 22: 1964 Ash Pond – downstream slope looking north along concrete flume carrying discharge from the 1982 Ash Pond.

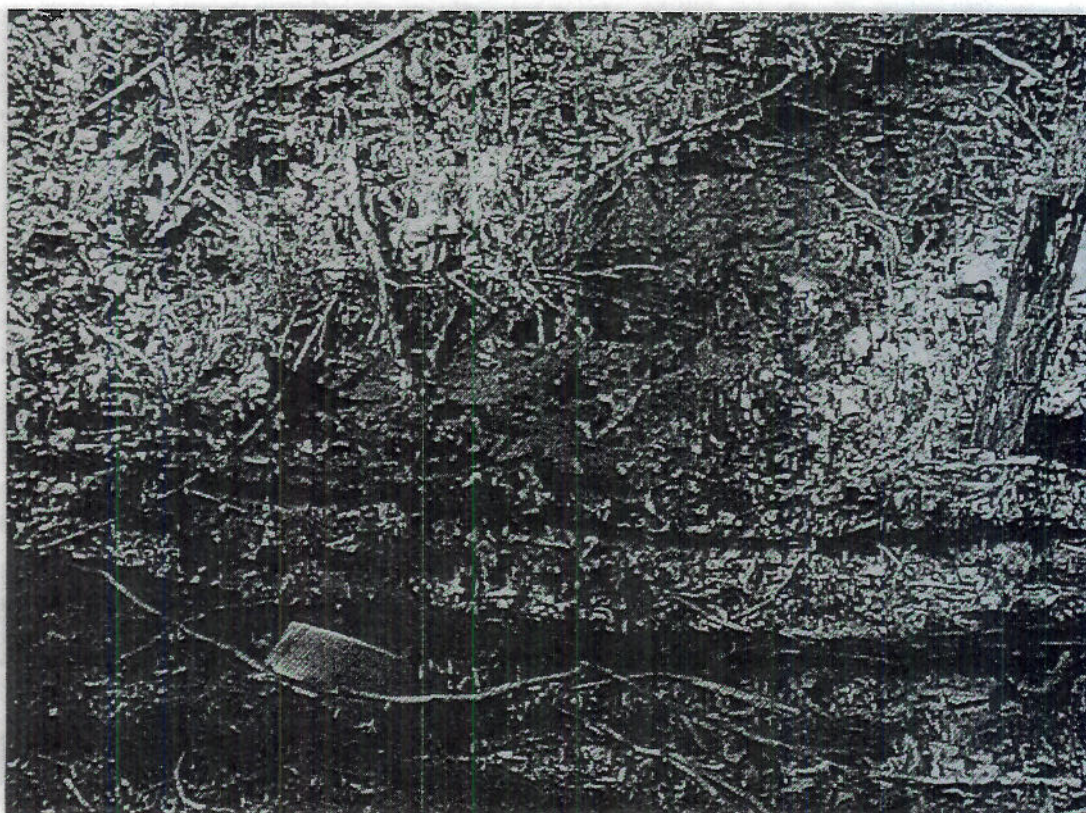
Photograph 24: 1964 Ash Pond – Outlet for drainage pipe installed beneath concrete flume.

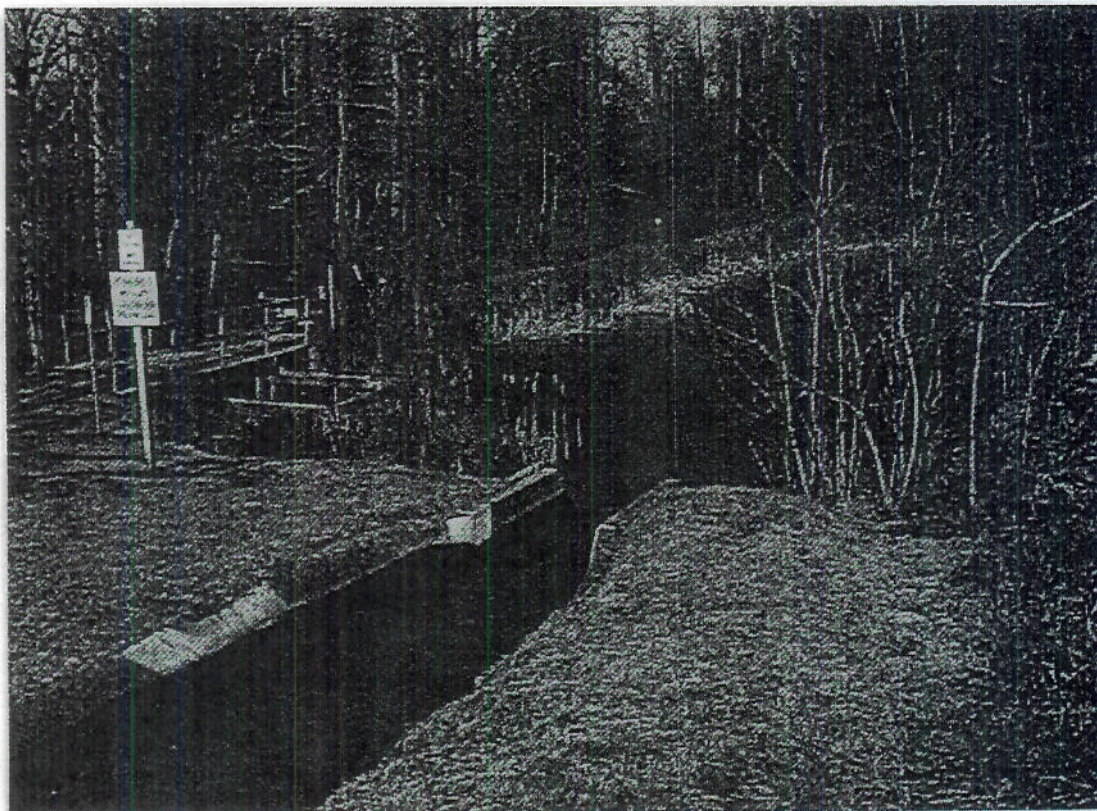
The skimmer, stilling basin and outlet structure are in good condition (photographs 25 and 26). No evidence of deteriorating concrete was observed at the outlet structure.

Photograph 26: 1964 Ash Pond – concrete flume discharge into stilling pond.

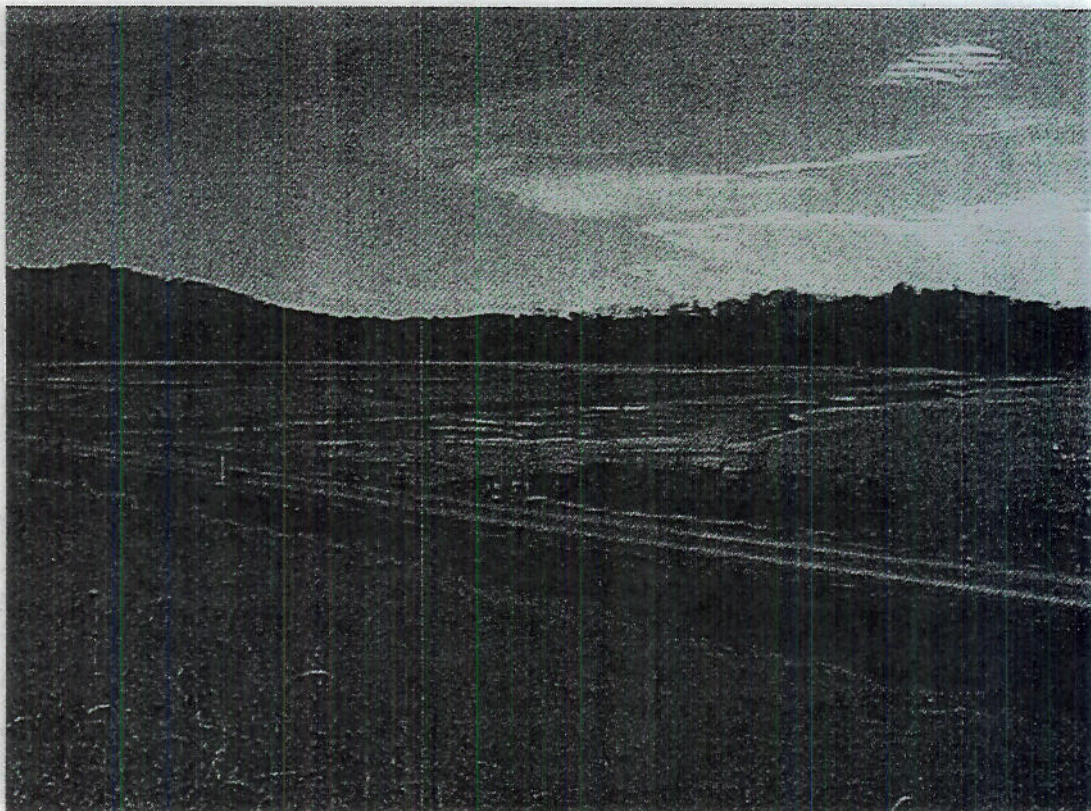
The internal ash dike, located within the northern half of the 1982 Ash Pond (photograph 28), was constructed in 2006 with ash excavated from the 1982 Ash Pond. The internal ash dike was observed to be in overall good condition. Grass cover was observed on the upstream and downstream slopes of the internal ash dike (photograph 29). The outlet pipe located at the southeast corner of the internal dike appears to be in good condition (photograph 30).

Photograph 28: 1982 Ash Pond and internal ash dike within 1982 Ash Pond, looking northeast.

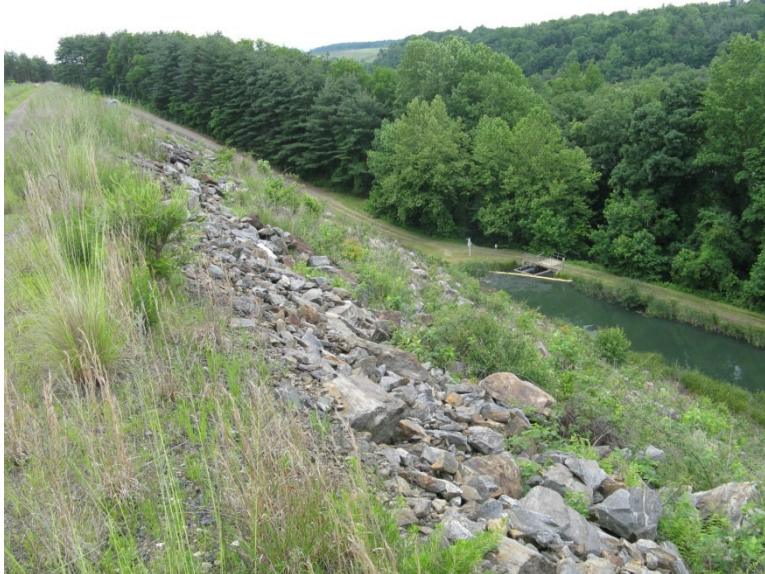
Photo 1: 1964 Dam - Downstream Embankment and Stilling Pond, Crest, Photo: 051, 5/29/09

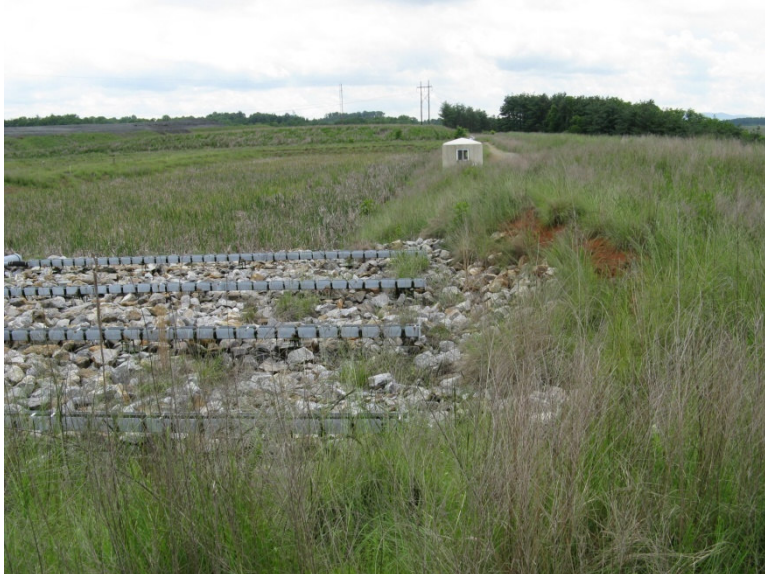
Photo 2: 1964 Dam - Upstream Wetland, Crest, Photo: 053, 5/29/09

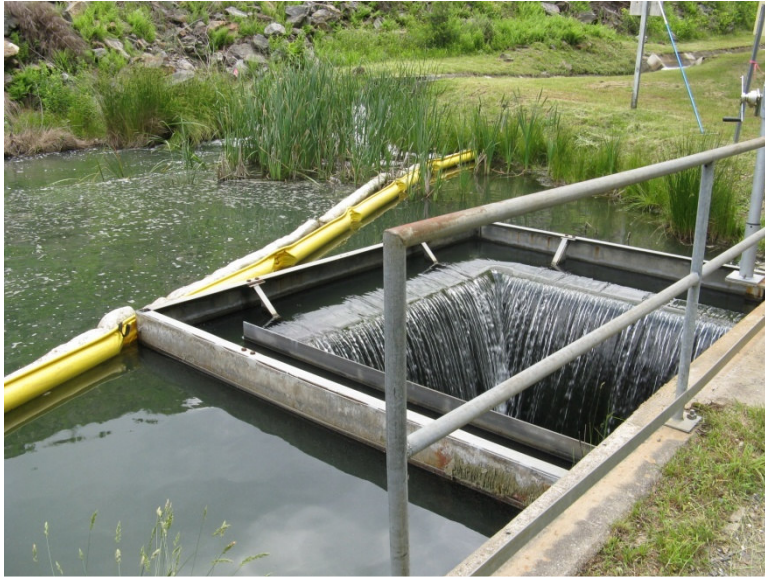
Photo 3: 1964 Dam - Stilling Pond Outlet, Toe, Photo: 070, 5/29/09

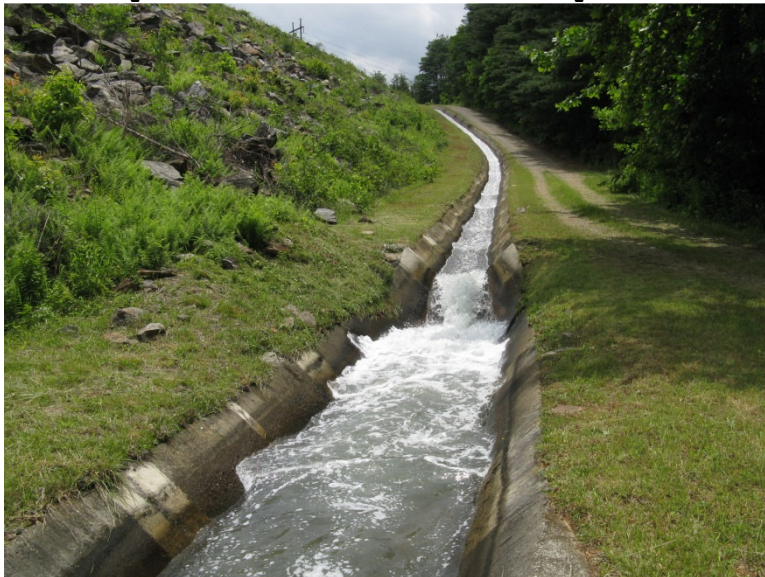
Photo 4: 1964 Dam - Concrete Flume, Right Groin, Photo: 083, 5/29/09
(note: right and left are based on the observer facing downstream)

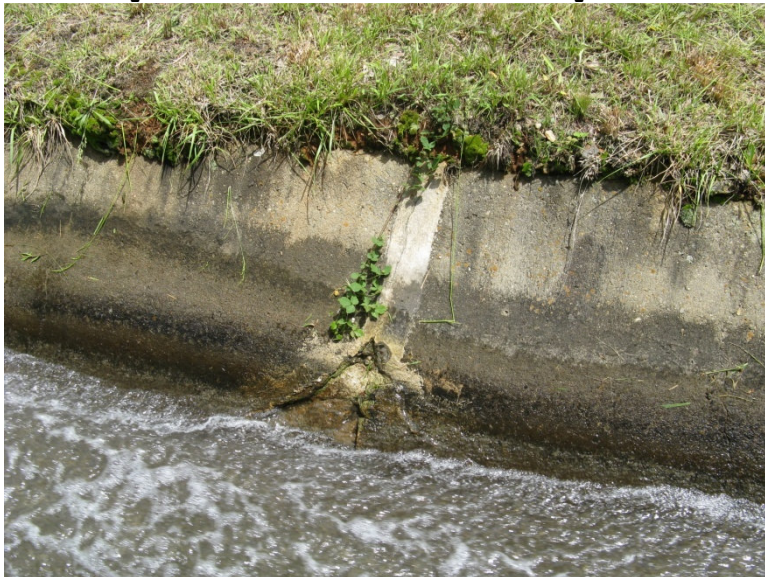
Photo 6: 1964 Dam - Concrete Flume Deterioration, Right Groin, Photo: 090, 5/29/09
(note: right and left are based on the observer facing downstream)

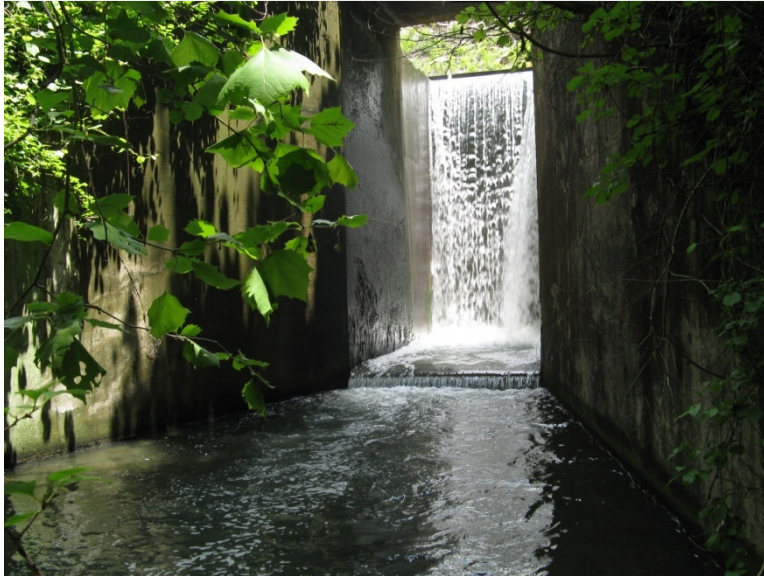
Photo 7: 1964 Dam - Stilling Pond Outfall, Toe, Photo: 086, 5/29/09

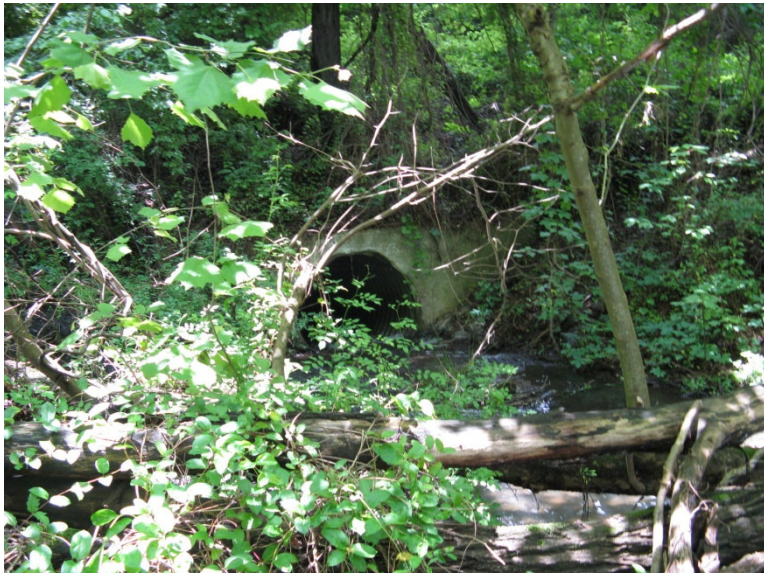
Photo 8: 1964 Dam - 60" CMP Underneath I-26, Toe, Photo: 087, 5/29/09

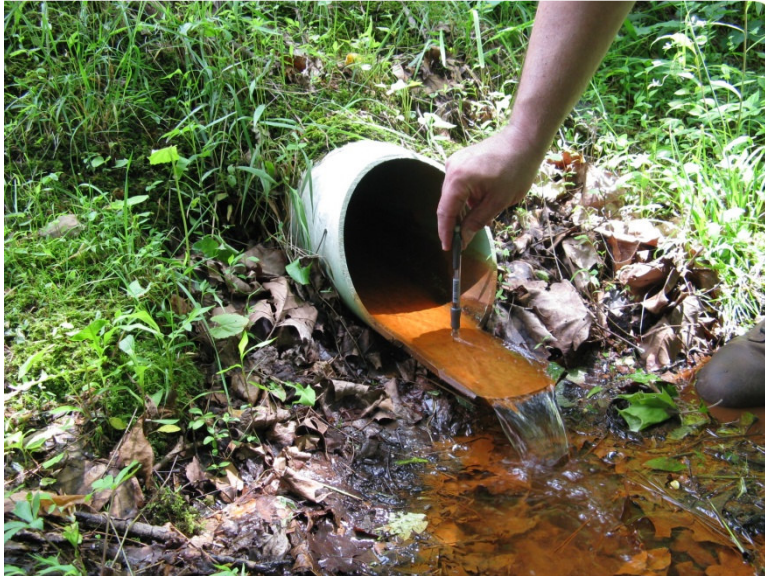
Photo 9: 1964 Dam – Internal Drain, Toe, Photo: 081, 5/29/09

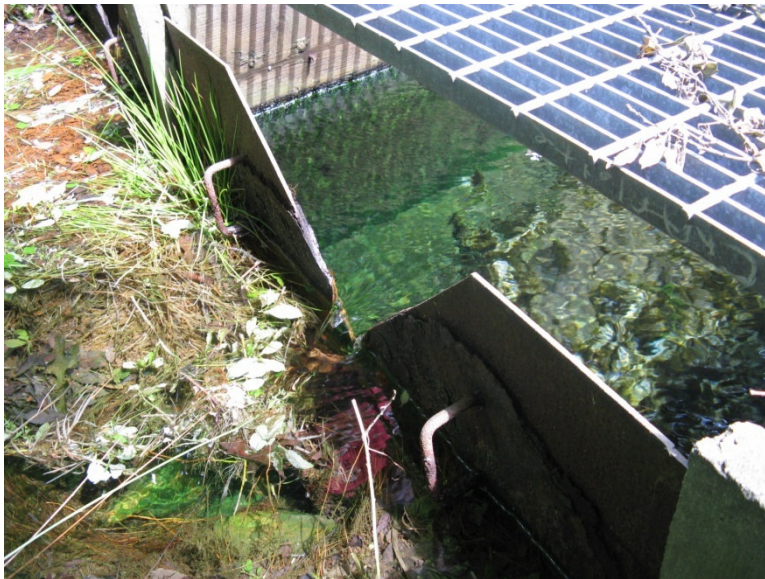
Photo 10: 1982 Dam - Weir Outlet for Internal Drain, Toe, Photo: 006, 5/29/09

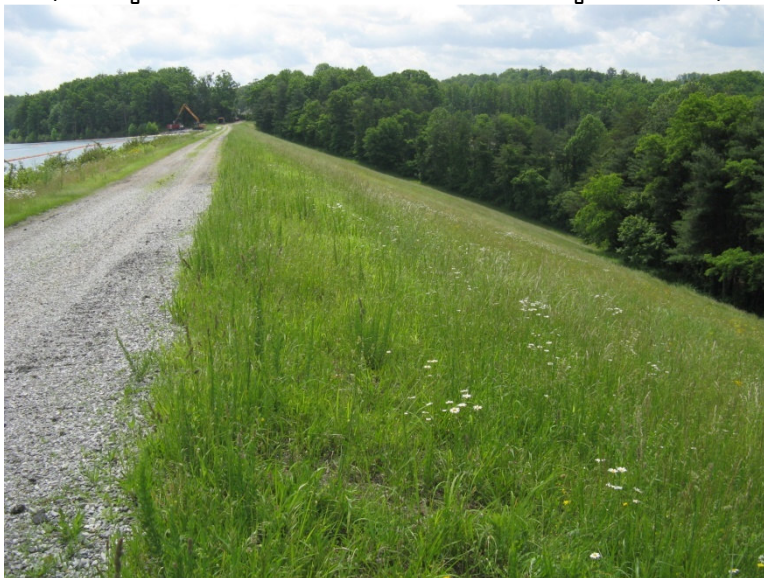
Photo 11: 1982 Dam - Crest and Downstream Embankment, Crest (Right Side), Photo: 021, 5/29/09
(note: right and left are based on the observer facing downstream)

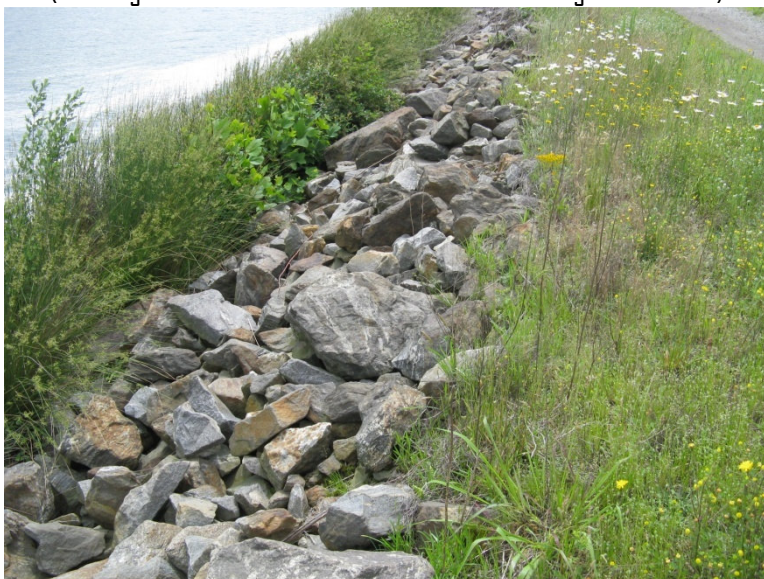
Photo 12: 1982 Dam - Upstream Embankment, Crest(Right Side), Photo: 024, 5/29/09
(note: right and left are based on the observer facing downstream)

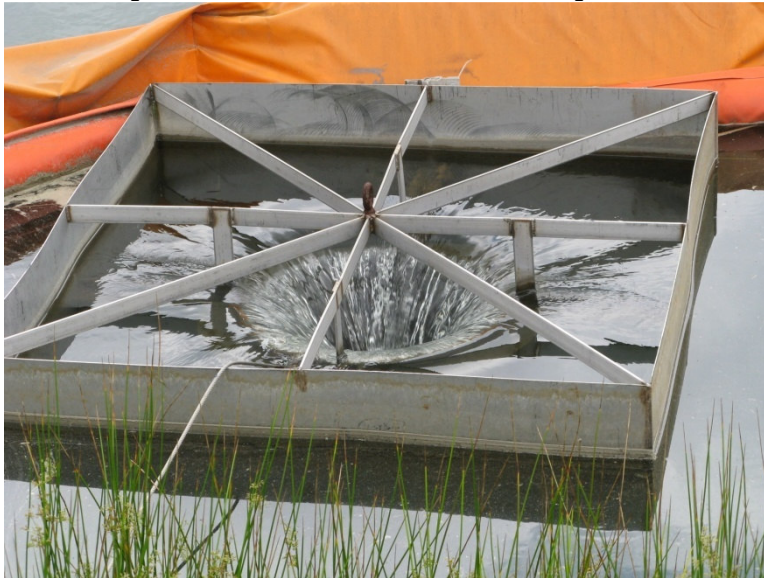
Photo 13: 1982 Dam - Primary Outlet, Right Abutment, Photo: 099, 5/29/09
(note: right and left are based on the observer facing downstream)

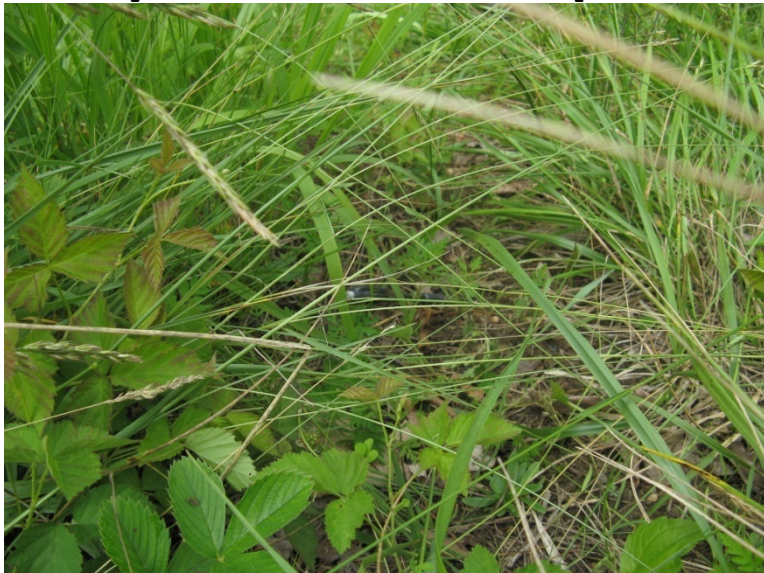
Photo 14: 1982 Dam - Animal Burrow, Downstream Embankment 50' Right of Piezometer, Photo: 028, 5/29/09
(note: right and left are based on the observer facing downstream)

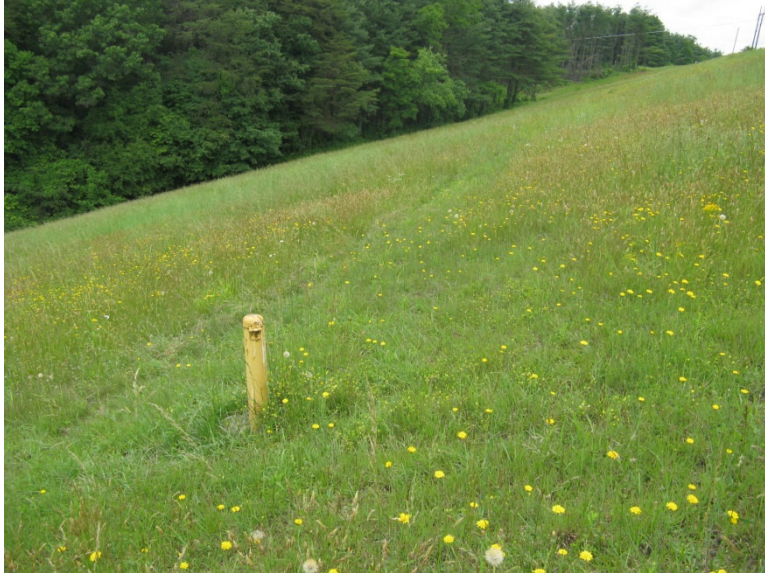
Photo 15: 1982 Dam - Midsection of Downstream Slope, Downstream Embankment, Photo: 030, 5/29/09

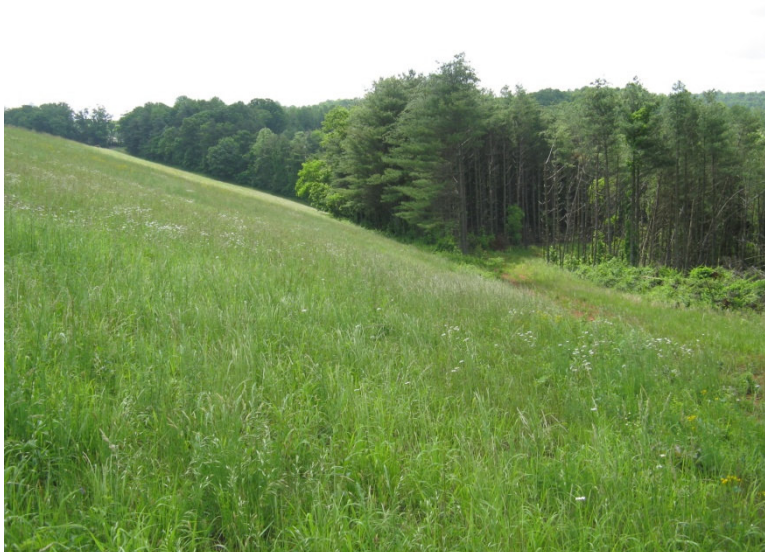
Photo 16: 1982 Dam - View of Right Groin, Right Abutment, Photo: 016, 5/29/09
(note: right and left are based on the observer facing downstream)

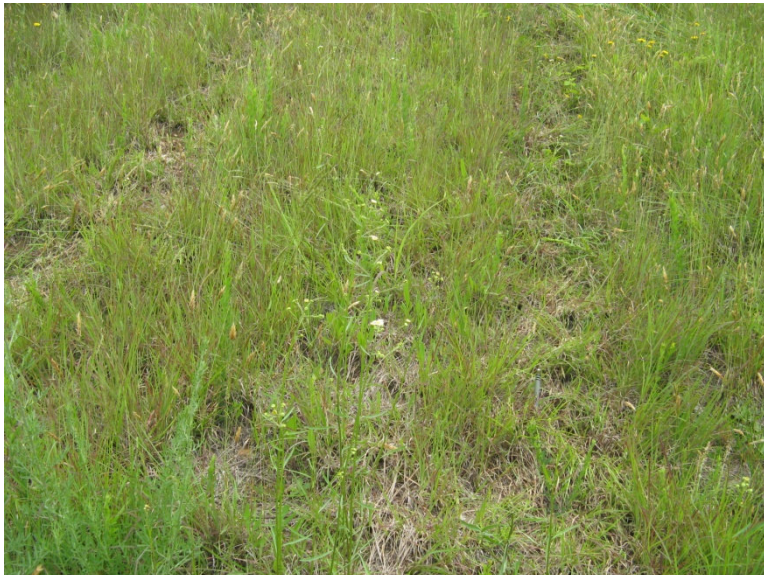
Photo 18: 1982 Dam – Minor Rill Erosion, Downstream Embankment, Photo: 033, 5/29/09
